## A new method to recognize the status of sic surge arresters in substations

### Abstract

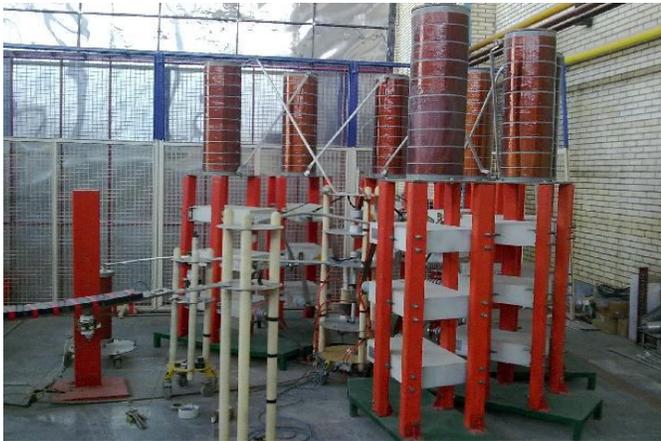
Fig. 5. The lightning current generator of the PLAC

Since the purpose of this paper is finding a method for recognizing correct and defective SiC lightning arresters in substations, none of the mentioned test is appropriate and feasible method for this aim. On the other hand, these tests should be carried out on the arresters to evaluate the performance of them. The first test which was carried out on the arresters was residual voltage test. In this test, 8/20 μs lightning current wave is applied to the lightning arresters with an amplitude depending on nominal voltage. If the arrester operates in the expected voltage, it can be concluded that the arrester is correct and if it does not operate, it is defective. The voltage in which the lightning arresters should act is called residual voltage and according to standard is defined as the voltage that indicates the protection offered by the arrester due to its voltage clamping action (Miller et al., 1991). To do this test, some lightning arresters shown in Table 1, were transferred to Pars Lightning Arresters Company (PLAC) and were tested in high voltage lab of this company. It should be mentioned that the performance of them were not clear before tests. The lightning current generator and its circuit are shown in Fig. 4 and Fig. 5.

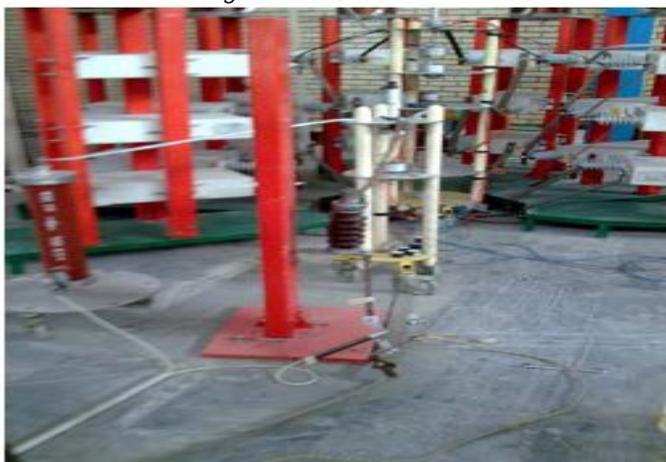
Fig. 6. TS1 arrester while test

As shown in the Fig. 6 and Fig. 7 applying the impulse wave, the TS1 arrester operated in 23 KV and with the operation of it 348 A current is grounded. But according to table 1, this arrester should have operated 33 KV. Hence the operation point of the arrester is changed and this fact proves the defection of this arrester that lightning arrester is out of order. Furthermore, the depicted oscillations at the beginning of the figure is due

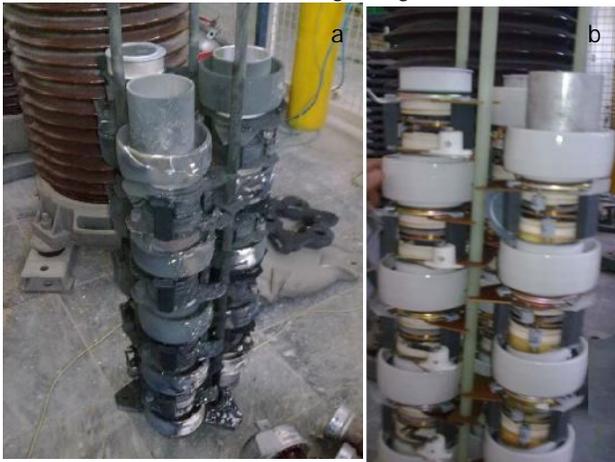
Fig.10. a. Inside of defected lightning arrester  
 b. Inside of correct lightning arrester

*Residual voltage test. sample no. TS4. 1 of 17 sections of arrester:* Since the impulse current generator of the PLAC had some limitation for creating current big enough for the operation of the 63 kV arrester, the test was carried out on sections of this arrester and hence the lightning arresters were opened and different sections of them were separated and the test results were developed for the arrester. After opening these arresters it was observed that despite the perfect appearance of one of the arresters the sections of another was completely ruined and defected. Fig. 10 shows the open scheme of these two lightning arresters.

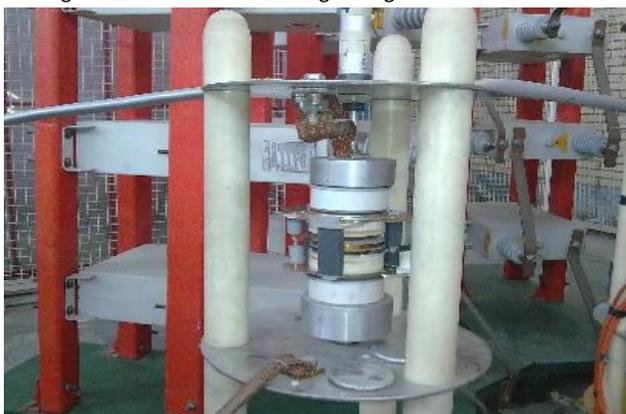
Fig. 11. A section of TS4 lightning arrester while test

It is shown in Fig.11 and Fig. 12 that one section operated in 10.2 (kV) and grounded 320 current. Developing the result of this test for all sections of lightning arrester it gains the voltage of 173.4 kV ( $10.2 \times 17 = 173.4$ ). As this voltage approximately equals the designed residual voltage, this lightning arrester is not defected. For ensuring the acquired result two section of this arrester is tested (Fig.13 and Fig. 14).

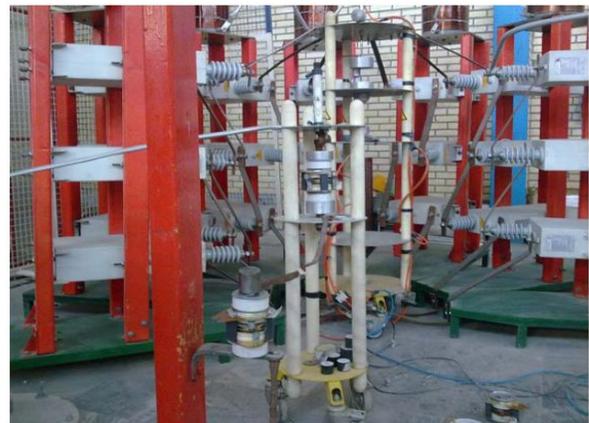
Fig. 13. A section of TS4 lightning arrester while test

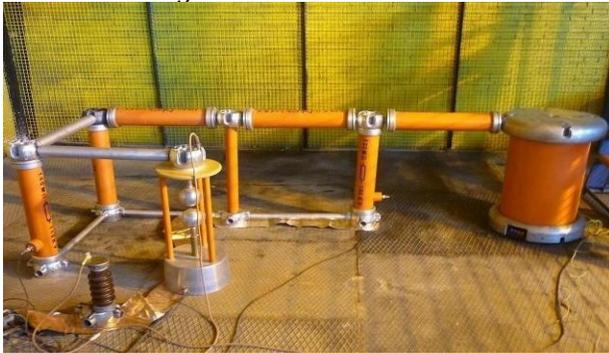
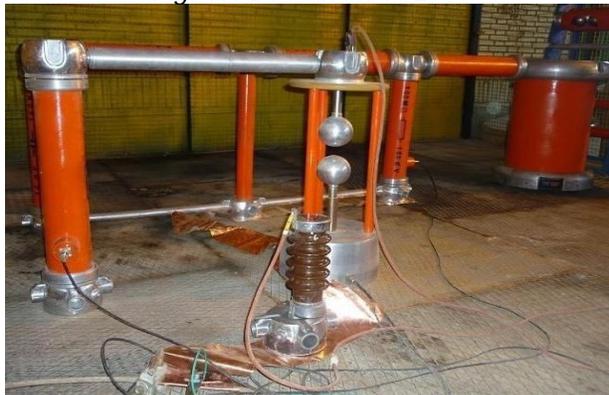
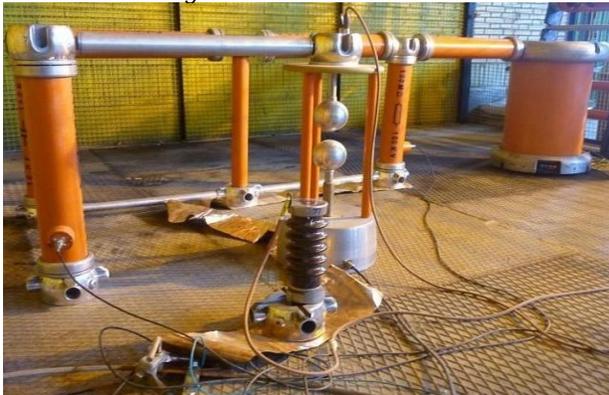
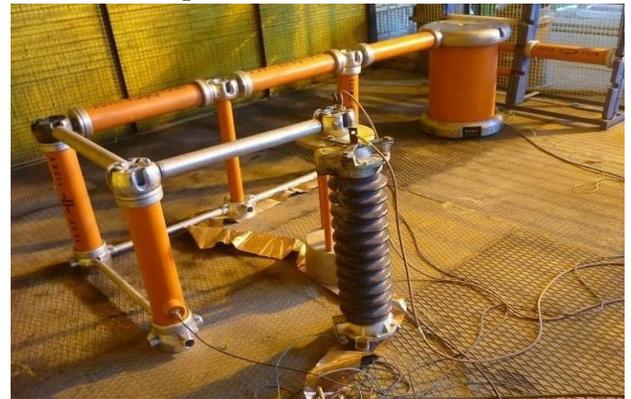
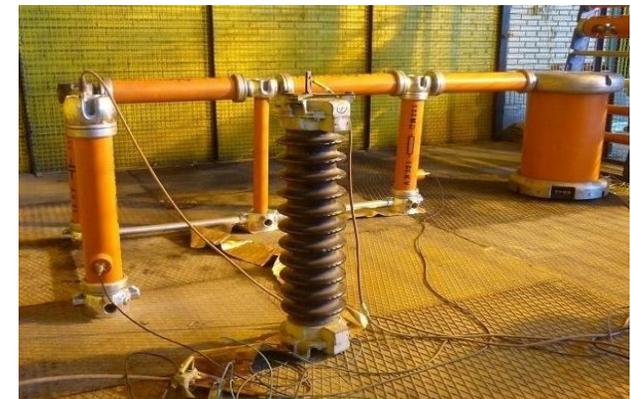
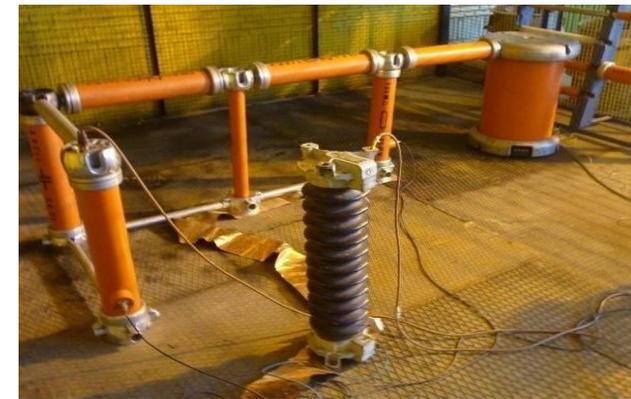
Fig.16. DC test on TS1

Fig. 17. DC test on TS2

Fig. 18. DC test on TS3

Fig. 19. DC test on TS4

Fig. 20. DC test on TS5

Fig. 21. DC test on TS6

According to acquired results from Table 3, the TS1, TS2 and TS3 lightning arresters that are recognized as defective in impulse test have similar result in DC test. In other hand, the 24(kV) lightning arresters of TS4 and TS5 have induced problem and were absolutely defective. Furthermore because of the two lightning arresters have no performance in lightning it was clear that either they have been transformed to insulator or they are in threshold level. By applying DC voltage, the two lightning arresters acted in voltages of 92(kV) and 95.6(kV). According to Table 2 their design residual voltage was 72(kV) and should have acted in that voltage. Hence they were defective. The TS6 has been a new 24(kV) lightning arrester that has not been installed in the network. After applying DC test the lightning arrester

acted in 73(kV). Comparing the performance of this arrester and residual voltage, it was clear that they have had correct performance. The images of DC test on these lightning arresters are shown in Fig. 16-21.

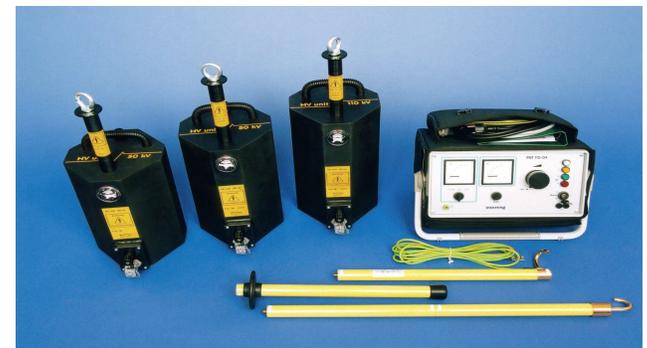
Fig. 22. Required equipments of producing a portable DC generator

equipments for doing DC test in the place are depicted in the Fig. 22.
